# Industrial Coating for the Protection of Floor Areas

**BELZONA**  
5231

Belzona 5231 (SG Laminate) is a two-component, liquid-applied coating system, designed for floor areas where chemical, abrasion and slip resistance are required.

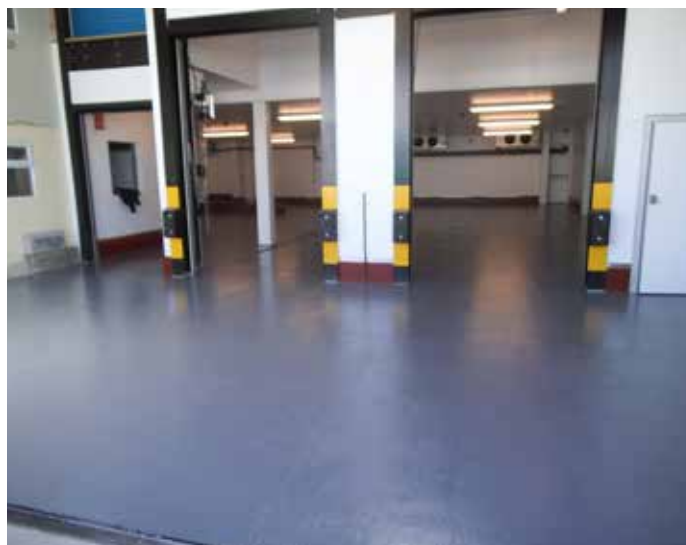
Dairy warehouse floor restored with Belzona 5231

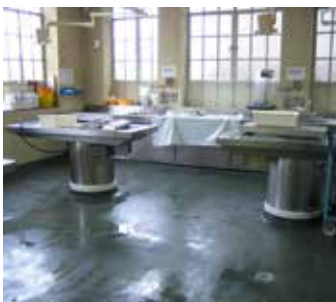
Concrete floor before

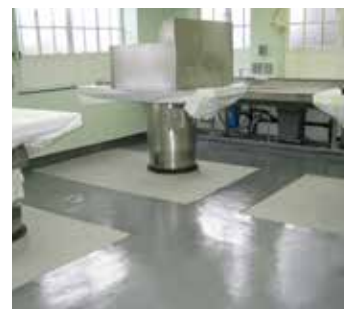
Concrete floor after

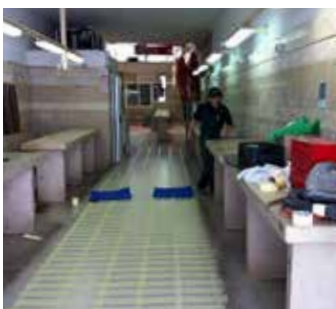
Tiled floor before

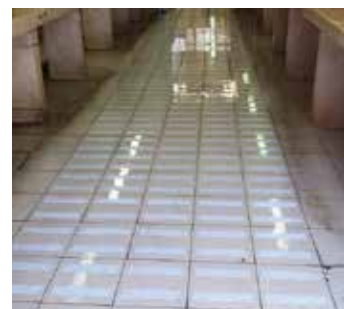
Tiled floor after
